PROYECTO FINAL DE CARRERA

Patología estructural y del casco:

Métodos de protección, inspección, mantenimiento y reparación

Ingeniería Naval y Oceánica
Junio, 2014

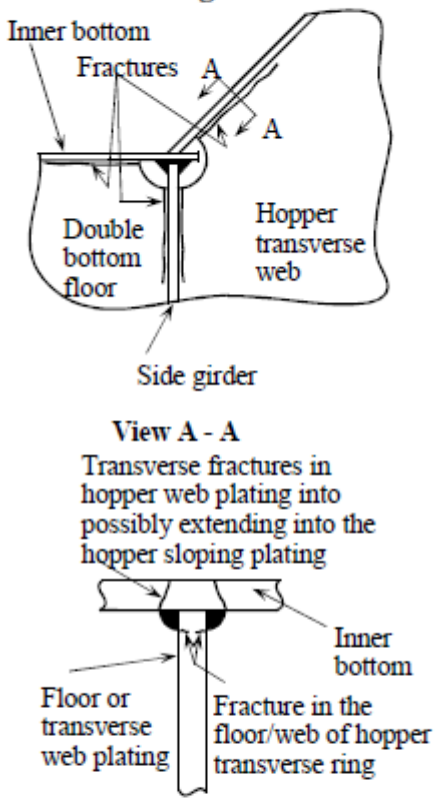
BULK CARRIERS		Guidelines for Surveys, Assessment and Repair of Hull Structure
Part 1	Cargo hold region	Example No.
Area 5	Double bottom tank structure including hopper	4
Detail of damage	Fractures at weld connections of floors in way of hopper/inner bottom interface (welded knuckle)	
Sketch of damage

<p>View A - A Transverse fractures in hopper web plating into possibly extending into the hopper sloping plating</p> <p>Fracture in the floor/web of hopper transverse ring</p>		Sketch of repair

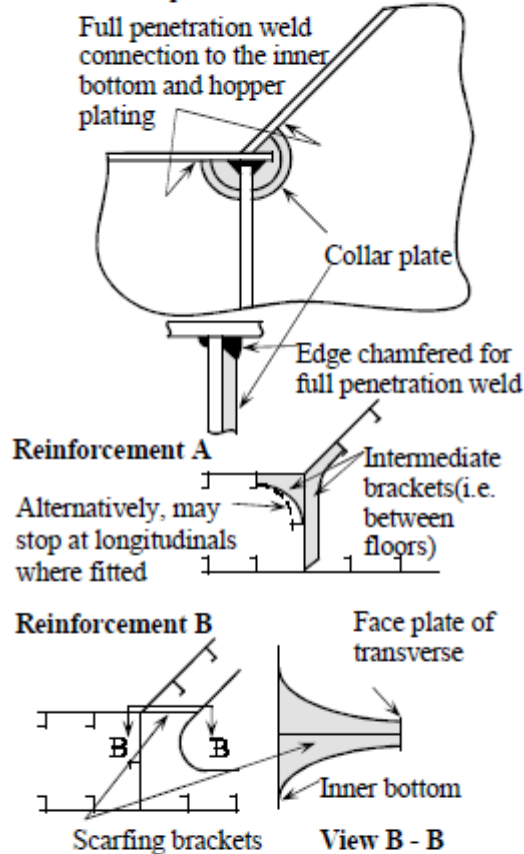
<p>Reinforcement A Alternatively, may stop at longitudinals where fitted</p> <p>Reinforcement B Face plate of transverse</p> <p>View B - B</p>
Notes on possible cause of damage 1. The damage is partly due to stress concentration at the edges of the weld created by the presence of the deflections in the inner bottom/hopper plating.		Notes on repairs 1. The fracture in the weld and/or plating is veed-out/cropped and renewed as appropriate. 2. The cut-outs are eliminated by introducing suitable collar plates with emphasis on edge preparation and sequence of welding as shown above. 3. Further reinforcements may be incorporated as shown above and depending on the judged cause of damage.

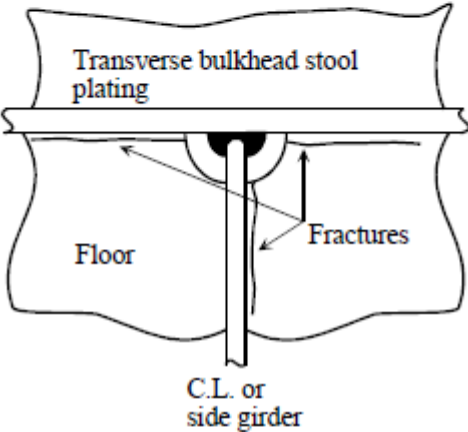
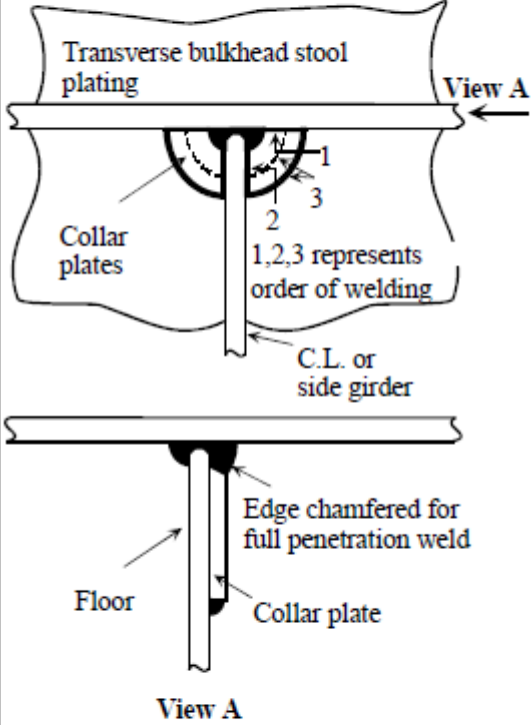
BULK CARRIERS		Guidelines for Surveys, Assessment and Repair of Hull Structure
Part 1	Cargo hold region	Example No.
Area 5	Double bottom tank structure including hopper	5
Detail of damage	Fractures at weld connections of floors in way of inner bottom and side girders, and plating of bulkhead stool	
Sketch of damage		Sketch of repair

Notes on possible cause of damage		Notes on repairs
1. Stress concentration at the welds due to scallops.		1. The scallops will require to be fitted with welded collar plates to reduce stresses in the area.

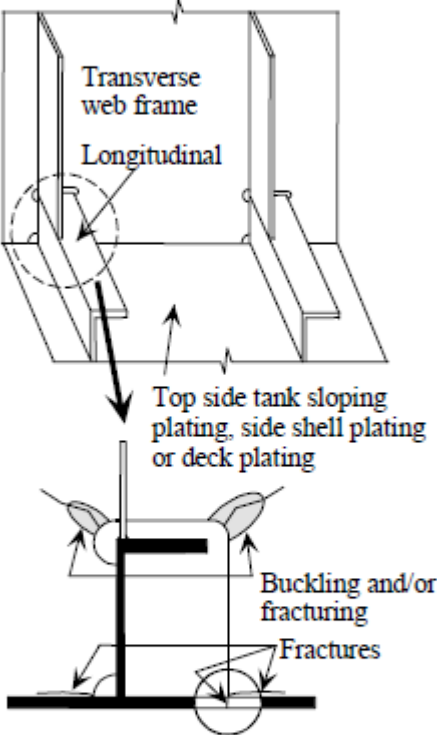
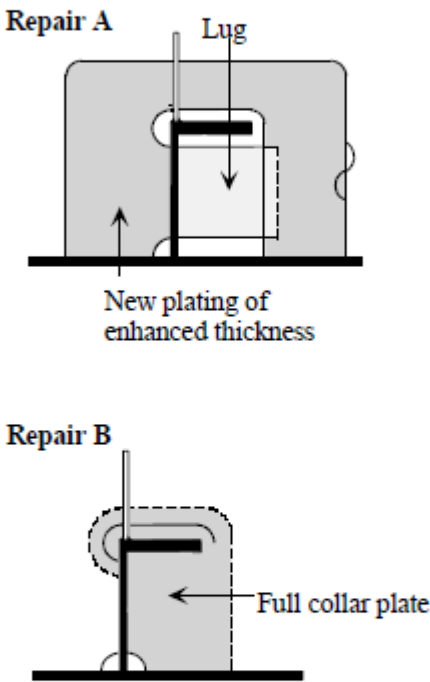
BULK CARRIERS		Guidelines for Surveys, Assessment and Repair of Hull Structure
Part 1	Cargo hold region	Example No.
Area 5	Double bottom tank structure including hopper	6
Detail of damage	Fractures and buckling in way of a cut-out for the passage of a longitudinal through a transverse primary member	
Sketch of damage		Sketch of repair

Notes on possible cause of damage		Notes on repairs
<ol style="list-style-type: none"> 1. Damage can be caused by general levels of corrosion and presence of stress concentration associated with the presence of a cut-out. 		<ol style="list-style-type: none"> 1. If fractures are significant then crop and part renew the floor plating/transverse web otherwise the fracture can be veed-out and welded provided the plating is not generally corroded. 2. Repair B is to be incorporated if the lug proves to be ineffective.

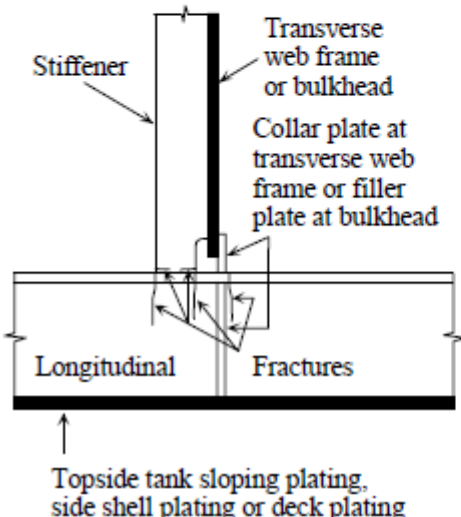
BULK CARRIERS		Guidelines for Surveys, Assessment and Repair of Hull Structure
Part 1	Cargo hold region	Example No.
Area 5	Double bottom tank structure including hopper	7
Detail of damage	Fractures in longitudinal at floor/transverse web frame or bulkhead	
Sketch of damage

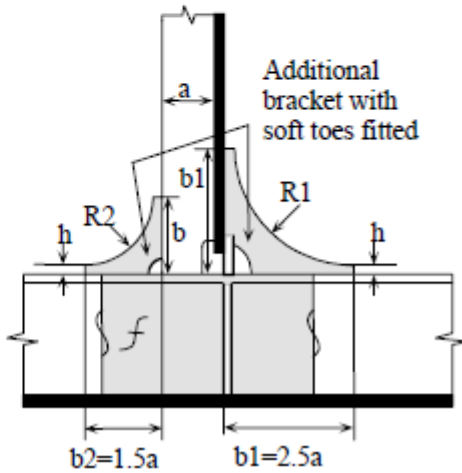
Sketch of repair

<p>f: Where required, the longitudinal to be cropped and part renewed</p> <ol style="list-style-type: none"> 1. For a slope at toes max 1:3, $R1=(b1-h) \times 1.6$ and $R2=(b2-h) \times 1.6$ 2. Soft toe bracket to be welded first to longitudinal 3. Scallop in bracket to be as small as possible, recommended max 35mm 4. If toes of brackets are ground smooth, full penetration welds in way to be provided 5. Maximum length to thickness ratio = 50:1 for unstiffened bracket edge 6. Toe height, h, to be as small as possible (10-15mm)
Notes on possible cause of damage 1. Damage can be caused by stress concentrations leading to accelerated fatigue in this region.		Notes on repairs 1. If fractures are not extensive e.g. hairline fractures, they can be veed-out and welded. 2. If fracture extends to over one third of the depth of the longitudinal then crop and part renew.

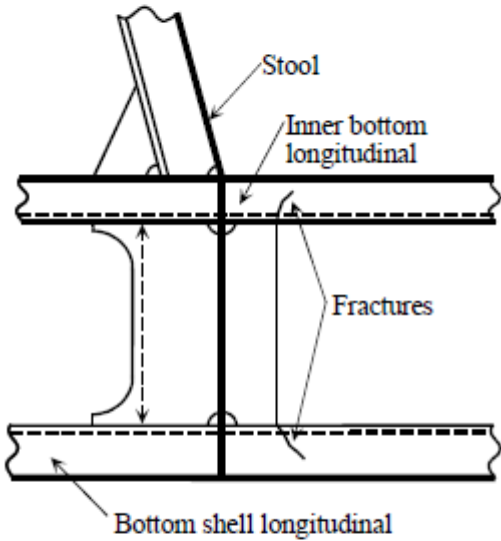
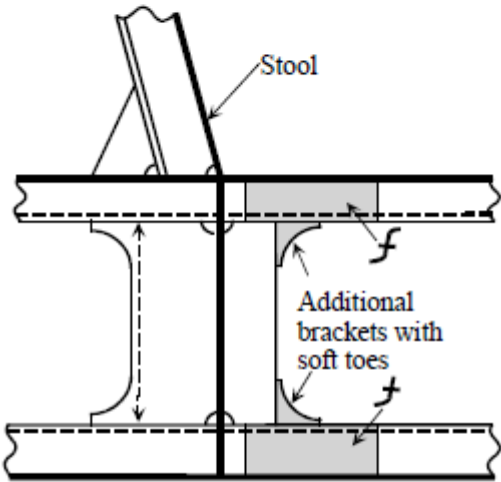
BULK CARRIERS		Guidelines for Surveys, Assessment and Repair of Hull Structure
Part 1	Cargo hold region	Example No.
Area 5	Double bottom tank structure including hopper	8
Detail of damage	Fractures in bottom and inner bottom longitudinals in way of inner bottom and bulkhead stool boundaries	
Sketch of damage		Sketch of repair

<p>f :Where required the longitudinal to be cropped and part renewed</p>
Notes on possible cause of damage		Notes on repairs
<ol style="list-style-type: none"> 1. Damage can be caused by stress concentration leading to accelerated fatigue in this region. 		<ol style="list-style-type: none"> 1. If fractures are not extensive e.g. hairline fractures then these can be veed-out and welded. 2. If fracture extended to over one third of the depth of the longitudinal depth then crop and part renew.

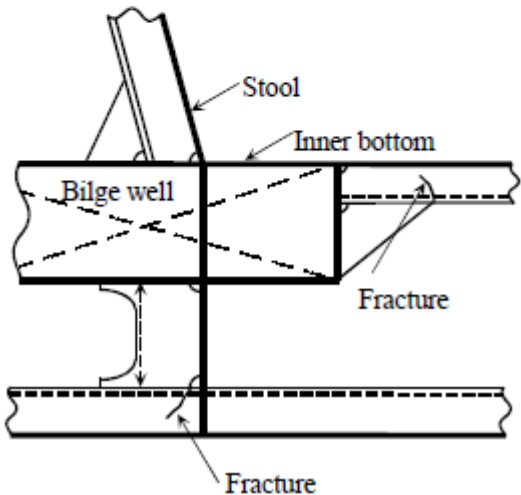
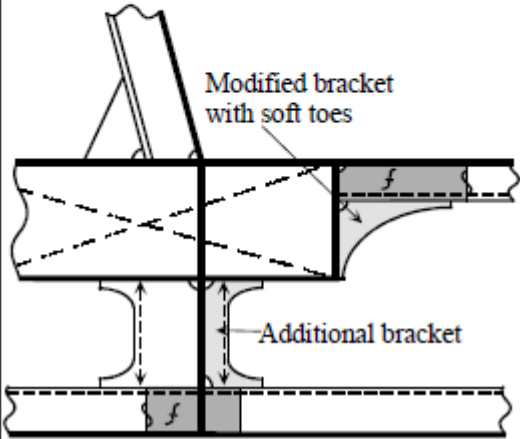
BULK CARRIERS		Guidelines for Surveys, Assessment and Repair of Hull Structure	
Part 1	Cargo hold region	Example No.	
Area 5	Double bottom tank structure including hopper	9	
Detail of damage		Fractures in longitudinal in way of bilge well	
Sketch of damage		Sketch of repair

<p>f: Where required the longitudinals to be cropped and part renewed</p>	
Notes on possible cause of damage 1. Damage can be caused by stress concentrations leading to accelerated fatigue in this region.		Notes on repairs 1. If fractures are not extensive e.g. hairline fractures then these can be veed-out and welded. 2. If the fracture extended to over one third of the depth of the longitudinal then crop and part renew.

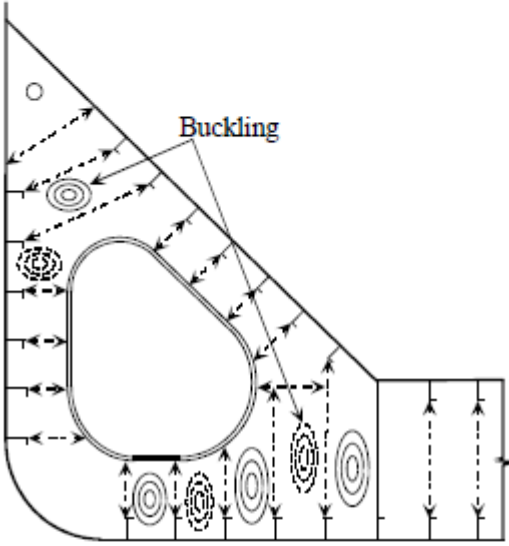
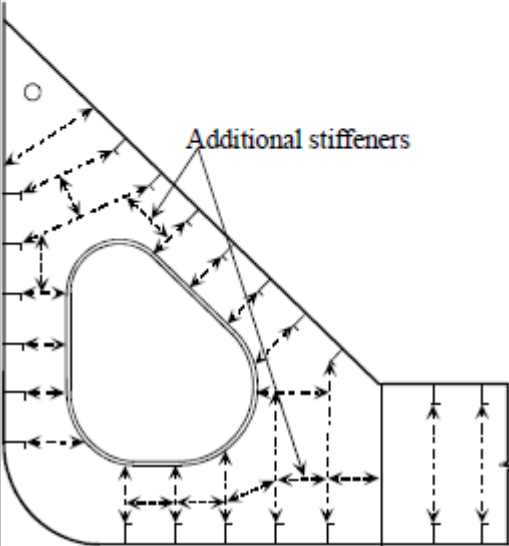
BULK CARRIERS		Guidelines for Surveys, Assessment and Repair of Hull Structure	
Part 1	Cargo hold region	Example No.	
Area 5	Double bottom tank structure including hopper	10	
Detail of damage		Buckling of transverse web	
Sketch of damage		Sketch of repair

Notes on possible cause of damage		Notes on repairs	
<ol style="list-style-type: none"> 1. Insufficient buckling strength of transverse web plating. 2. Corrosion of high stress area. 		<ol style="list-style-type: none"> 1. If the buckling occurred without significant corrosion, adequate reinforcement is to be carried out. 2. If the buckling occurred due to corrosion of high stress (shear stress) area, damaged area is to be cropped and part renewed. Adequate reinforcement and protective measures should be considered.

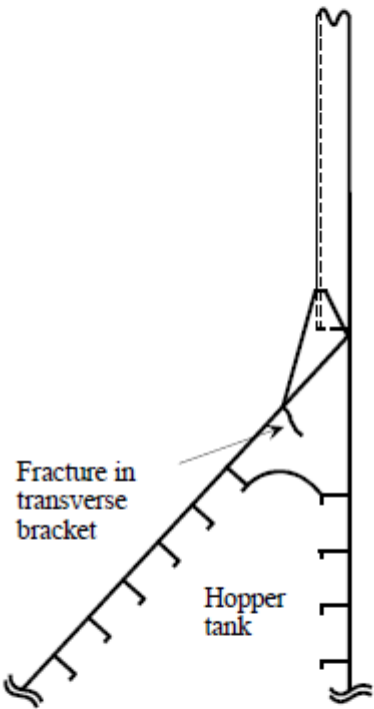
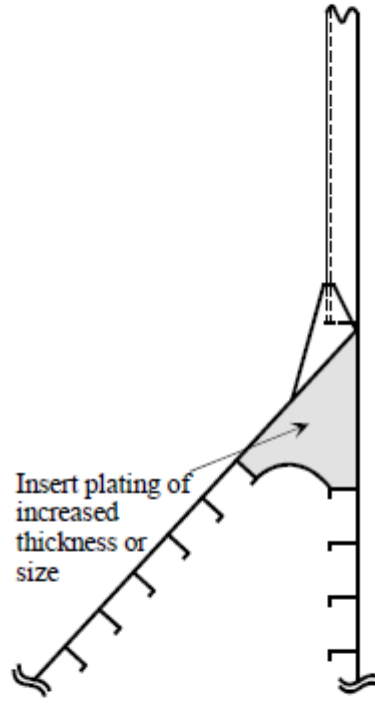
BULK CARRIERS		Guidelines for Surveys, Assessment and Repair of Hull Structure
Part 1	Cargo hold region	Example No.
Area 5	Double bottom tank structure including hopper	11
Detail of damage Fractures at weld connection of transverse brackets		
Sketch of damage		Sketch of repair

Notes on possible cause of damage		Notes on repairs
<ol style="list-style-type: none"> 1. General levels of corrosion and presence of stress concentration. 2. Misalignment of the brackets with adjoining structure e.g. frame brackets. 3. High shear stresses due to insufficient bracket. 4. Inadvertent overloading. 		<ol style="list-style-type: none"> 1. If the damage is caused by misalignment with the frame bracket above, the misalignment is to be rectified. 2. Replacement by a bracket of increased thickness or size should be considered.

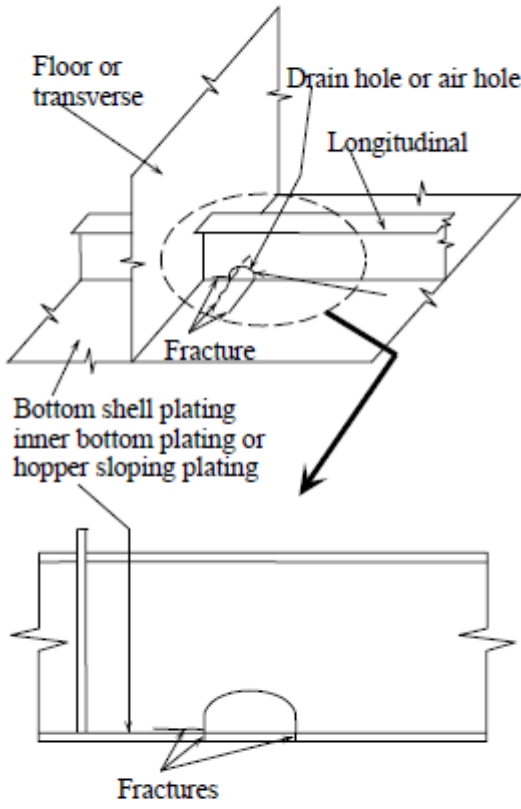
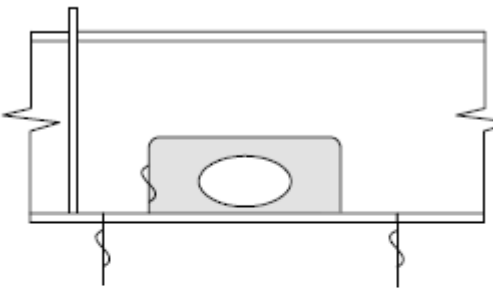
BULK CARRIERS		Guidelines for Surveys, Assessment and Repair of Hull Structure
Part 1	Cargo hold region	Example No.
Area 5	Double bottom tank structure including hopper	12
Detail of damage	Fractures in bottom shell/side shell/hopper sloping plating at the corner drain hole/air hole in longitudinal	
Sketch of damage		Sketch of repair

Notes on possible cause of damage		Notes on repairs
<ol style="list-style-type: none"> 1. Stress concentration and/or corrosion due to stress concentration at the corner of drain hole/air hole. 		<ol style="list-style-type: none"> 1. Fractured plating should be cropped and part renewed. 2. If fatigue life is to be improved, change of drain hole/air hole shape is to be considered.

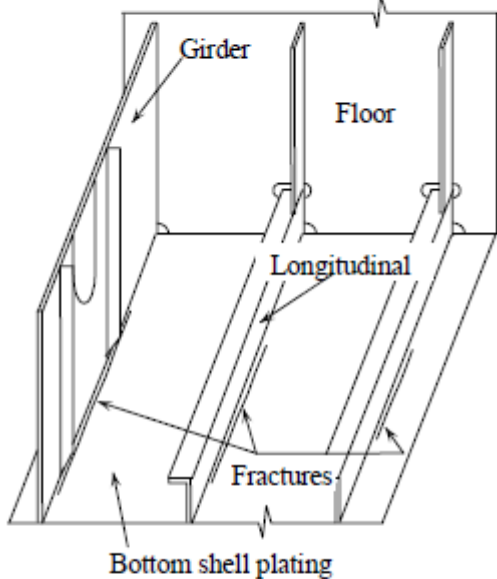
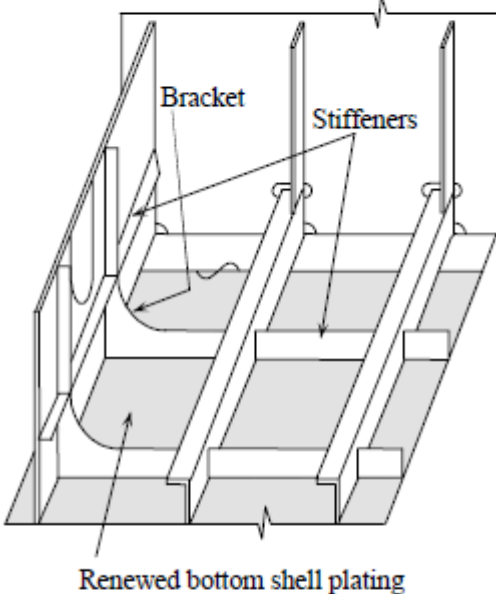
BULK CARRIERS		Guidelines for Surveys, Assessment and Repair of Hull Structure
Part 1	Cargo hold region	Example No.
Area 5	Double bottom tank structure including hopper	13
Detail of damage	Fractures in bottom plating along side girder and/or bottom longitudinal	
Sketch of damage		Sketch of repair

Notes on possible cause of damage		Notes on repairs
1. Vibration.		1. Fractured bottom shell plating should be cropped and renewed. 2. Natural frequency of the panel should be changed, e.g. reinforcement by additional stiffener/bracket.

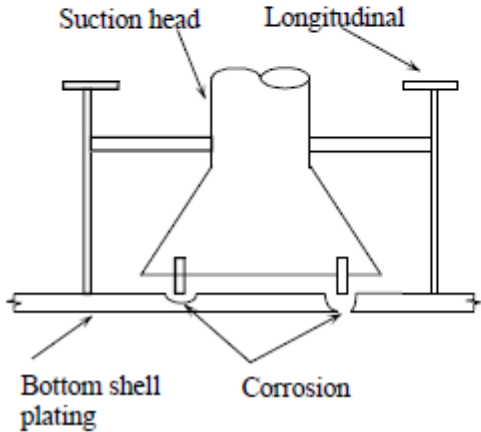
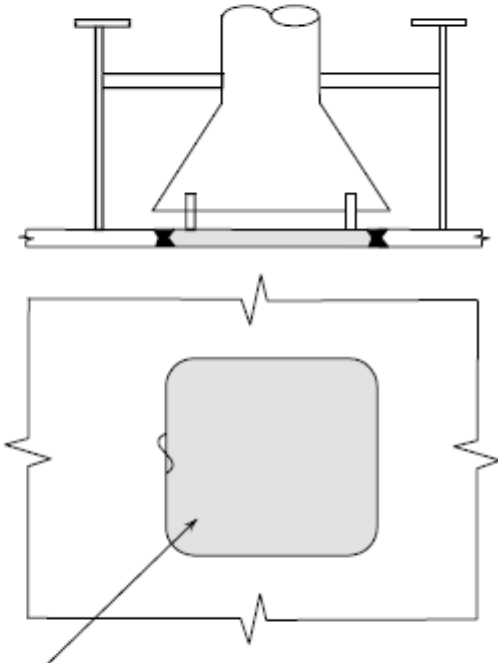
BULK CARRIERS		Guidelines for Surveys, Assessment and Repair of Hull Structure	
Part 1	Cargo hold region	Example No.	
Area 5	Double bottom tank structure including hopper	14	
Detail of damage		Corrosion in bottom plating below suction head	
Sketch of damage		Sketch of repair

<p>1. Insert to have round corners 2. Non-destructive examination to be applied after welding based on the Society's rules</p>	
Notes on possible cause of damage		Notes on repairs	
<ol style="list-style-type: none"> 1. High flow rate associated with insufficient corrosion prevention system. 2. Galvanic action between dissimilar metals. 		<ol style="list-style-type: none"> 1. Affected plating should be cropped and part renewed. Thicker plate and suitable beveling should be considered. 2. If the corrosion is limited to a small area, i. e. pitting corrosion, repair by welding is acceptable.

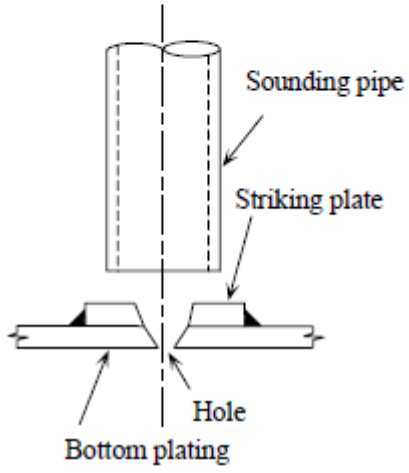
BULK CARRIERS		Guidelines for Surveys, Assessment and Repair of Hull Structure
Part 1	Cargo hold region	Example No.
Area 5	Double bottom tank structure including hopper	15
Detail of damage Corrosion in bottom plating below sounding pipe		
Sketch of damage

</div> </div>
Notes on possible cause of damage <ol style="list-style-type: none"> 1. Accelerated corrosion of striking plate by the striking of the weight of the sounding tape. 		Notes on repairs <ol style="list-style-type: none"> 1. Corroded bottom plating should be welded or partly cropped and renewed if considered necessary. 2. Corroded striking plate should be renewed.

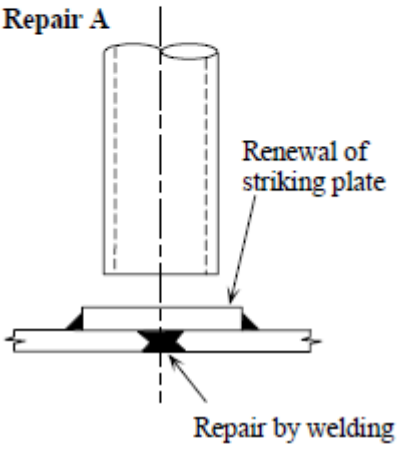
Sketch of repair <div style="display: flex; flex-direction: column; align-items: center;"> <div style="text-align: center;"> Repair A

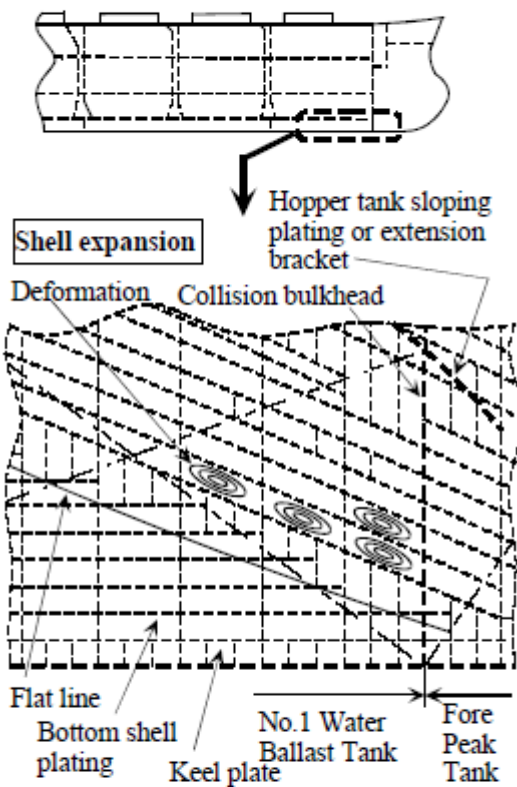
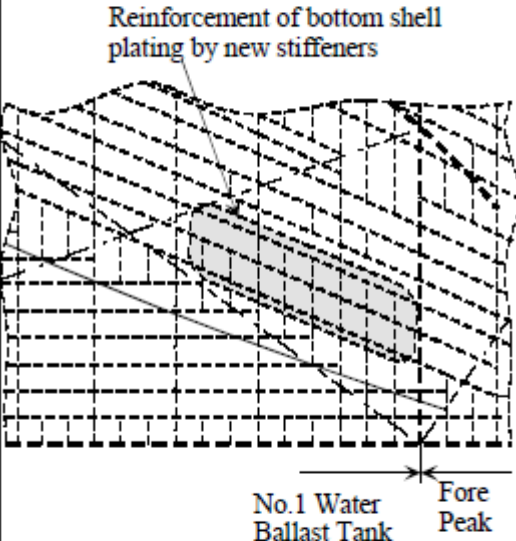
BULK CARRIERS		Guidelines for Surveys, Assessment and Repair of Hull Structure
Part 1	Cargo hold region	Example No.
Area 5	Double bottom structure including hopper	16
Detail of damage Deformation of forward bottom shell plate due to slamming		
Sketch of damage		Sketch of repair

Notes on possible cause of damage		Notes on repairs
<ol style="list-style-type: none"> 1. Heavy weather. 2. Poor design for slamming. 3. Poor operation, i.e. negligence of heavy ballast. 		<ol style="list-style-type: none"> 1. Deformed bottom shell plating should be faired in place, or partly cropped and renewed if considered necessary. 2. Bottom shell plating should be reinforced by stiffeners.

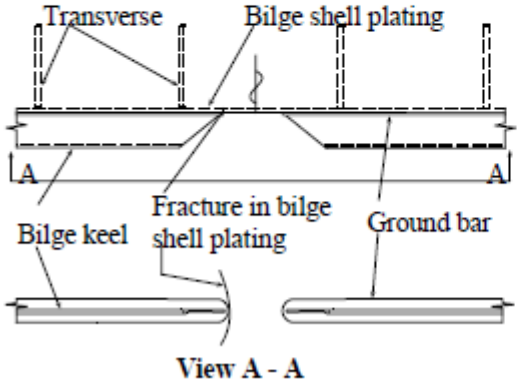
BULK CARRIERS		Guidelines for Surveys, Assessment and Repair of Hull Structure
Part 1	Cargo hold region	Example No.
Area 5	Double bottom structure including hopper	17
Detail of damage		Fractures in shell plating at the termination of bilge keel
Sketch of damage		Sketch of repair

<p>Transverse</p> <p>Bilge shell plating</p> <p>Fracture in bilge shell plating</p> <p>Bilge keel</p> <p>Ground bar</p> <p>View A - A</p>		<p>Repair A</p>

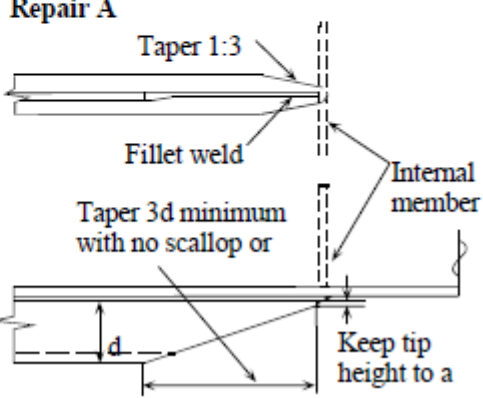
<p>Taper 1:3</p> <p>Fillet weld</p> <p>Taper 3d minimum with no scallop or</p> <p>Internal member</p> <p>Keep tip height to a</p> <p>d</p> <p>Repair B</p>

<p>Newly provided stiffeners</p>
Notes on possible cause of damage		Notes on repairs
<ol style="list-style-type: none"> Poor design causing stress concentration. 		<ol style="list-style-type: none"> Fractured plating is to be cropped and renewed. Reduction of stress concentration of the bilge keel end should be considered. <p>Repair A: Modification of the detail of end</p> <p>Repair B: New internal stiffeners</p> <p>Repair C: Continuous ground bar (in connection with Repair A)</p> Instead of Repair A or B continuous ground bar and bilge keel should be considered.

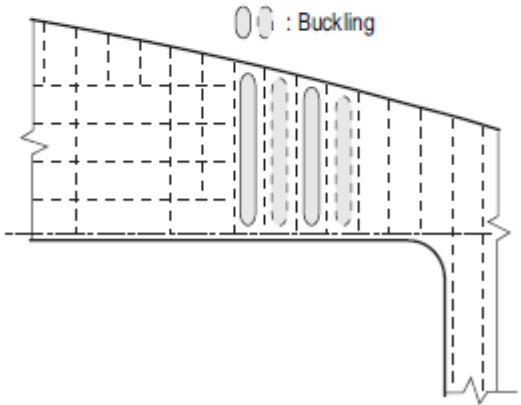
CONTAINER SHIPS		Guidelines for Surveys, Assessment and Repair of Hull Structures	
PART 1	Cargo hold region	EXAMPLE No.	
AREA 1	Upper deck structure including passageways	1	
Detail of damage		Buckling of deck plating of transverse framing system	
<p>Sketch of damage</p>

<p>View A-A</p>	
<p>Notes on possible cause of damage</p> <ol style="list-style-type: none"> Excessive compressive stress due to slamming or bow flare effect. Insufficient longitudinal stiffening of deck plating. 		<p>Notes on repairs</p> <ol style="list-style-type: none"> Buckled plating should be cropped and renewed. Longitudinal internal stiffeners should be provided. (Instead of longitudinal stiffeners, renewal by thicker deck plating can be accepted.) Stress concentration may occur at the end of a sniped stiffener resulting in fatigue fractures. For locations where high cyclic stress may occur, appropriate connection such as lug-connection should be considered.

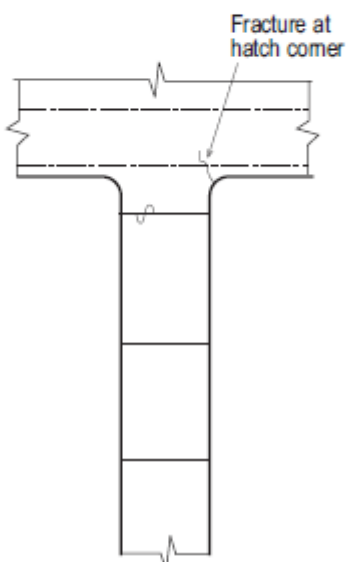
CONTAINER SHIPS		Guidelines for Surveys, Assessment and Repair of Hull Structures	
PART 1	Cargo hold region		EXAMPLE No.
AREA 1	Upper deck structure including passageways		2-a
Detail of damage		Fractures at main cargo hatch corner	
<p>Sketch of damage</p>

<p>Notes on possible cause of damage</p> <p>1. Stress concentration at hatch corners, i.e. radius of corner.</p>		<p>Notes on repairs</p> <p>1. The corner plating in way of the fracture is to be cropped and renewed. If stress concentration is the primary cause, insert plate should be of increased thickness, enhanced steel grade and/or improved geometry. Insert plate should be continued beyond the longitudinal and transverse extent of the hatch corner radius ellipse or parabola, and the butt welds to the adjacent deck plating should be located well clear of the butts in the hatch coaming. It is recommended that the edges of the insert plate and the butt welds connecting the insert plates to the surrounding deck plating be made smooth by grinding. In this respect caution should be taken to ensure that the micro grooves of the grinding are parallel to the plate edge.</p>

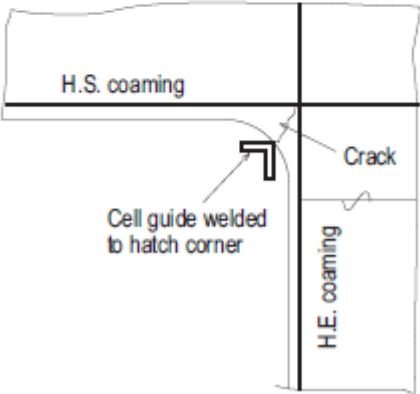
CONTAINER SHIPS		Guidelines for Surveys, Assessment and Repair of Hull Structures	
PART 1	Cargo hold region		EXAMPLE No.
AREA 1	Upper deck structure including passageways		2-b
Detail of damage		Fractures at main cargo hatch corner initiated from welded joint of cell guide	
<p>Sketch of damage</p>

<p>Notes on possible cause of damage</p> <p>1. In addition to high stress of hatch corner welded connection of cell guide caused stress concentration.</p>		<p>Notes on repairs</p> <ol style="list-style-type: none"> 1. Fractured deck plating is to be cropped and renewed. 2. Welding of cell guides to deck plating at hatch corner is to be avoided. 3. Cell guide should be connected to ship structure below deck level. 4. Alternatively an integration of the cell guide into the hatch corner could be considered.

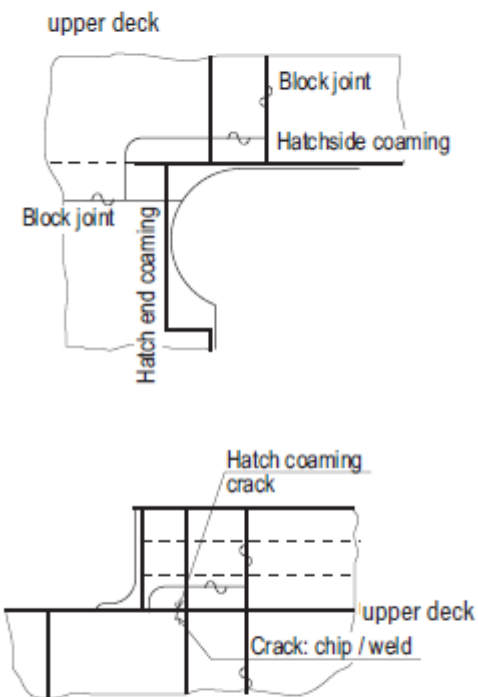
CONTAINER SHIPS		Guidelines for Surveys, Assessment and Repair of Hull Structures	
PART 1	Cargo hold region		EXAMPLE No.
AREA 1	Upper deck structure including passageways		2-c
Detail of damage		Fractures at main cargo hatch corner initiated at sniped end of stiffener	
<p>Sketch of damage</p>

<p>Notes on possible cause of damage</p> <p>1. In addition to high stress at hatch corner sniped end of stiffener (for buckling) caused stress.</p>		<p>Notes on repairs</p> <p>1. Fractured deck plating is to be cropped and renewed.</p> <p>2. Stiffener is to be removed. If necessary, thicker deck plating is to be considered.</p>

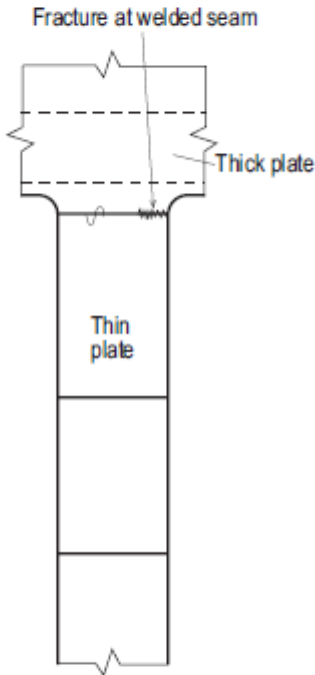
CONTAINER SHIPS		Guidelines for Surveys, Assessment and Repair of Hull Structures	
PART 1	Cargo hold region		EXAMPLE No.
AREA 1	Upper deck structure including passageways		3-a
Detail of damage		Fracture of welded seam between thick plate and thin plate at cross deck	
<p>Sketch of damage</p>

<p>Notes on possible cause of damage</p> <ol style="list-style-type: none"> 1. Stress concentration created by abrupt change in deck plating thickness. 2. In-plane bending in cross deck strip due to torsional (longitudinal) movements of ship sides. 3. Welded seam not clear of tangent point of hatch corner. 		<p>Notes on repairs</p> <ol style="list-style-type: none"> 1. Insert plate of intermediate thickness is recommended. 2. Smooth transition between plates (beveling) should be considered.

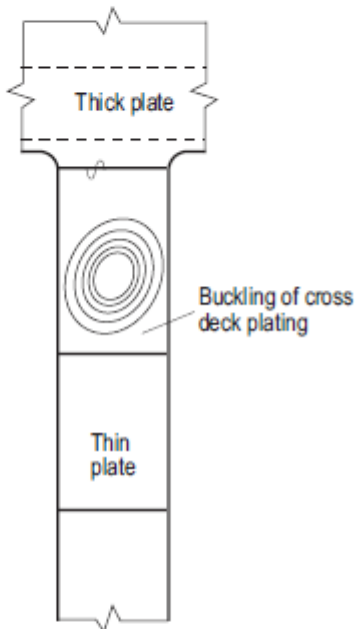
CONTAINER SHIPS		Guidelines for Surveys, Assessment and Repair of Hull Structures	
PART 1	Cargo hold region		EXAMPLE No.
AREA 1	Upper deck structure including passageways		3-b
Detail of damage		Plate buckling in thin plate near thick plate at cross deck	
<p>Sketch of damage</p>

<p>Notes on possible cause of damage</p> <ol style="list-style-type: none"> 1. In-plane shear of cross deck strip due to torsional (longitudinal) deflection of ship sides, often in combination with corrosion. 2. Insufficient transverse stiffening. 		<p>Notes on repairs</p> <ol style="list-style-type: none"> 1. Transverse stiffeners extending from hatch sides towards centerline at least 10% of breadth of hatch, and/or increased plate thickness in the same area.

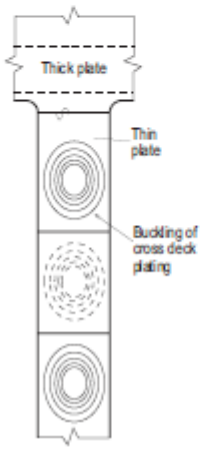
CONTAINER SHIPS		Guidelines for Surveys, Assessment and Repair of Hull Structures	
PART 1	Cargo hold region		EXAMPLE No.
AREA 1	Upper deck structure including passageways		3-c
Detail of damage		Overall buckling of cross deck plating	
<p>Sketch of damage</p>

<p>Notes on possible cause of damage</p> <ol style="list-style-type: none"> 1. Transverse compression of deck due to sea load. 2. Insufficient transverse stiffening. 		<p>Notes on repairs</p> <ol style="list-style-type: none"> 1. Repair A Plating of original thickness in combination with additional transverse stiffening. 2. Repair B Insertion of plating of increased thickness.

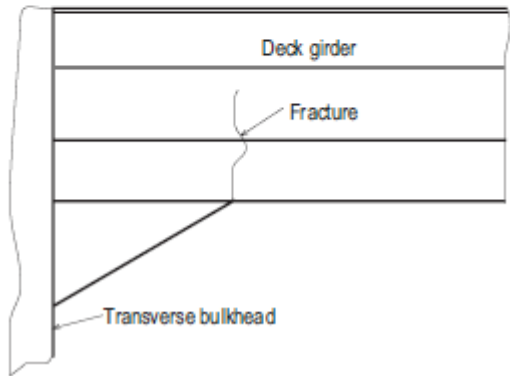
CONTAINER SHIPS		Guidelines for Surveys, Assessment and Repair of Hull Structures	
PART 1	Cargo hold region		EXAMPLE No.
AREA 1	Upper deck structure including passageways		4
Detail of damage		Fracture in longitudinal deck girder initiated at bracket toe	
<p>Sketch of damage</p>

<p>Notes on possible cause of damage</p> <ol style="list-style-type: none"> 1. Stress concentration at the toe of deck girder bracket. 		<p>Notes on repairs</p> <ol style="list-style-type: none"> 1. Fractured plating should be cropped and part renewed. 2. Modified soft bracket should be considered.

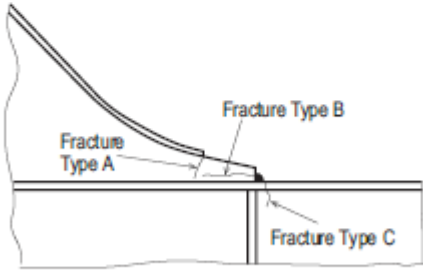
CONTAINER SHIPS		Guidelines for Surveys, Assessment and Repair of Hull Structures	
PART 1	Cargo hold region	EXAMPLE No.	
AREA 1	Upper deck structure including passageways	5	
Detail of damage		Fractures in continuous longitudinal hatch coaming extension bracket	
<p>Sketch of damage</p>

<p>Notes on possible cause of damage</p> <ol style="list-style-type: none"> 1. Flange force at the end of the flange too high due to insufficient tapering (Fracture Type A, propagating in the web). 2. Shear force in the web plate too high due to insufficient reduction of the web height at the end (Fracture Type B, propagating in the web at the undercut or HAZ of the fillet weld). 3. Insufficient support of the extension bracket below the deck (Fracture Type C, starting from undercut or HAZ of the fillet weld and propagating in the deck plating). 		<p>Notes on repairs</p> <ol style="list-style-type: none"> 1. Extend the extension bracket as long as possible to arrange a gradual transition. 2. Reduce the web height at the end of the bracket; in case of high stress areas grind smooth the transition to the deck plating welding. 3. Reduce the cross sectional area of the flange at the end as far as possible. 4. Provide longitudinal structure in way of the web of the extension bracket to the next transverse structure or provide a new transverse structure.

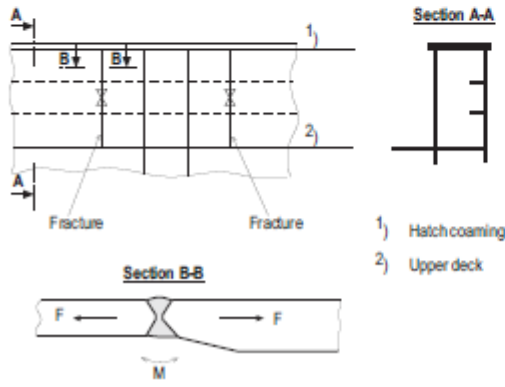
CONTAINER SHIPS		Guidelines for Surveys, Assessment and Repair of Hull Structures	
PART 1	Cargo hold region		EXAMPLE No.
AREA 1	Upper deck structure including passageways		6
Detail of damage		Fractures in hatch side coaming	
<p>Sketch of damage</p>

<p>1) Hatch coaming 2) Upper deck</p>		<p>Sketch of repair</p>

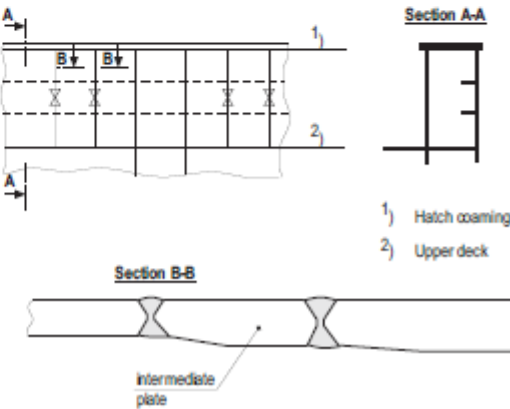
<p>1) Hatch coaming 2) Upper deck</p> <p>intermediate plate</p>	
<p>Notes on possible cause of damage</p> <p>1. Additional stress caused by bending moment due to the difference of thickness.</p>		<p>Notes on repairs</p> <p>1. Fractured plating is to be cropped and renewed.</p> <p>2. Insert of plate of intermediate thickness is to be considered.</p>

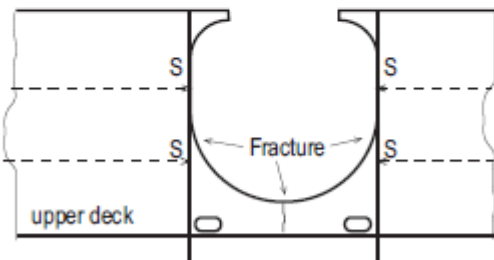
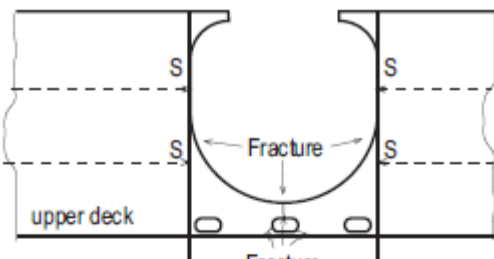
CONTAINER SHIPS		Guidelines for Surveys, Assessment and Repair of Hull Structures	
PART 1	Cargo hold region	EXAMPLE No.	
AREA 1	Upper deck structure including passageways	7	
Detail of damage		Fracture in access hole of longitudinal hatch coaming	
<p>Sketch of damage</p>

<p>Sketch No. 1 a</p>

<p>Sketch No. 1 b</p>		<p>Sketch of repair</p>

<p>Notes on possible cause of damage</p> <p>1. Coincidence of maximum increased stress due to the reduction of the hatch coaming with the metallurgical notches due to the welding seams in web and flat bar located at the same position.</p>		<p>Notes on repairs</p> <p>1. Hatch coaming to be continuous.</p> <p>2. Access opening to be provided.</p> <p>3. Drain holes to be elliptical and located above fillet weld to deck.</p> <p>4. Hatch coaming stiffeners of same material as coaming</p>

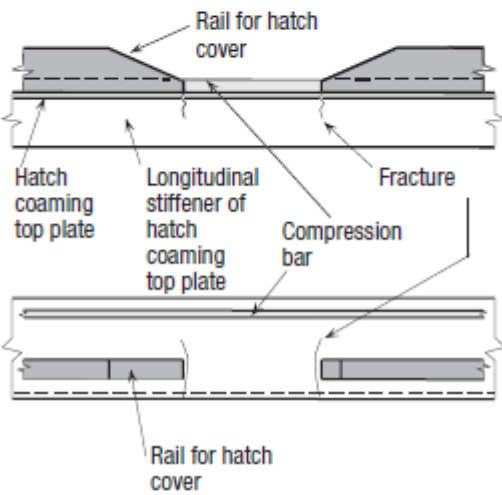
CONTAINER SHIPS		Guidelines for Surveys, Assessment and Repair of Hull Structures	
PART 1	Cargo hold region		EXAMPLE No.
AREA 1	Upper deck structure including passageways		8-a
Detail of damage		Fractures in hatch coaming top plate at the termination of the rail for hatch cover	
<p>Sketch of damage</p>

<p>Labels: Rail for hatch cover, Hatch coaming top plate, Longitudinal stiffener of hatch coaming top plate, Fracture, Compression bar, Rail for hatch cover.</p>		<p>Sketch of repair</p>

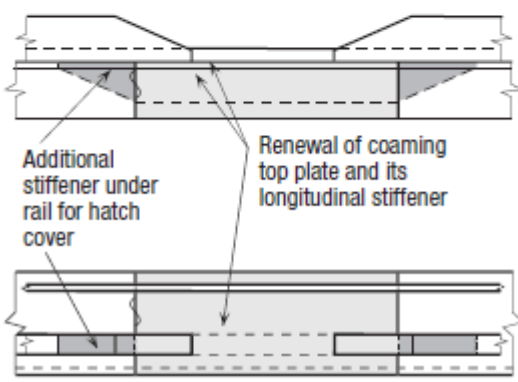
<p>Labels: Additional stiffener under rail for hatch cover, Renewal of coaming top plate and its longitudinal stiffener.</p>	
<p>Notes on possible cause of damage</p> <p>1. Stress concentration at the termination of the rail for hatch cover due to poor design.</p>		<p>Notes on repairs</p> <p>1. Fractured plate is to be cropped and part renewed.</p> <p>2. Thicker insert plate and/or reinforcement by additional stiffener under the top plate should be considered. Also refer to Example 8-b.</p>

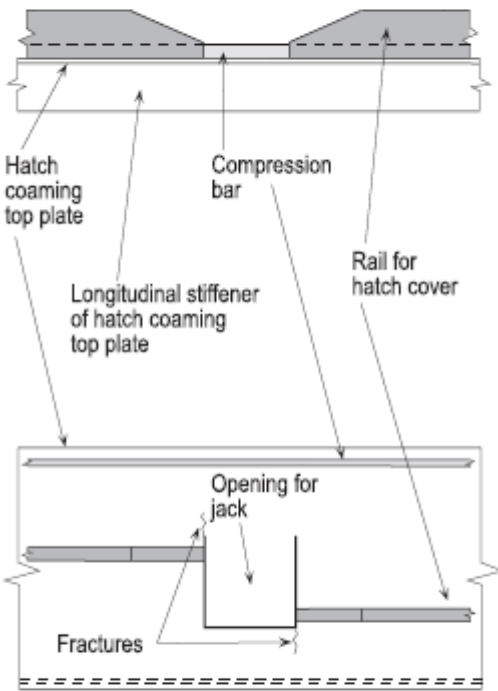
CONTAINER SHIPS		Guidelines for Surveys, Assessment and Repair of Hull Structures	
PART 1	Cargo hold region		EXAMPLE No.
AREA 1	Upper deck structure including passageways		8-b
Detail of damage		Fractures in hatch coaming top plate at the termination of the rail for hatch cover	
<p>Sketch of damage</p>

<p>Hatch coaming top plate</p> <p>Longitudinal stiffener of hatch coaming top plate</p> <p>Compression bar</p> <p>Rail for hatch cover</p> <p>Opening for jack</p> <p>Fractures</p>		<p>Sketch of repair</p>

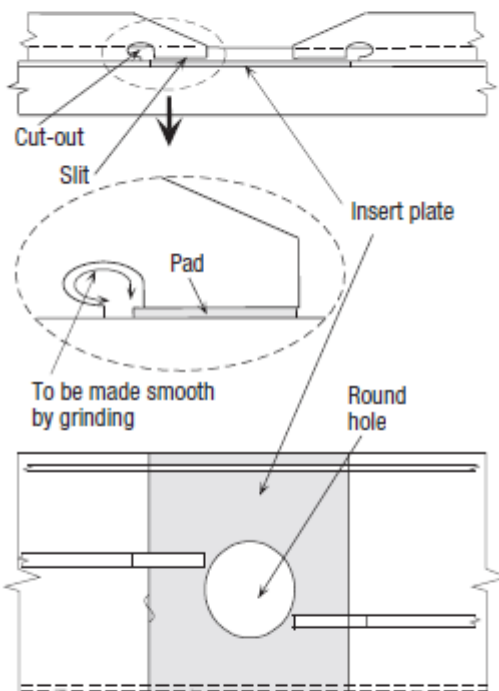
<p>Cut-out</p> <p>Slit</p> <p>Insert plate</p> <p>Pad</p> <p>To be made smooth by grinding</p> <p>Round hole</p>	
<p>Notes on possible cause of damage</p> <ol style="list-style-type: none"> 1. Stress concentration at the termination of the rail for hatch cover due to poor design of opening. 		<p>Notes on repairs</p> <ol style="list-style-type: none"> 1. Fractured plate is to be cropped and part renewed. 2. Thicker insert plate and/or reduction of stress concentration adopting large radius should be considered. Or cut-out in the rail and detachment of the welds as shown in the above drawing should be considered in order to reduce the stress of the corner of the opening.

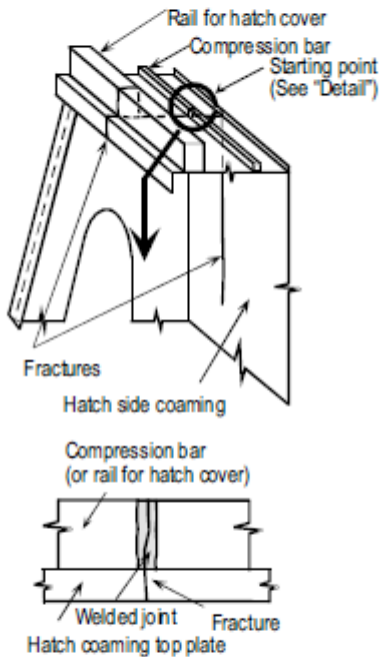
CONTAINER SHIPS		Guidelines for Surveys, Assessment and Repair of Hull Structures	
PART 1	Cargo hold region	EXAMPLE No.	
AREA 1	Upper deck structure including passageways	9	
Detail of damage		Fractures in hatch coaming top plate initiated from butt weld of compression bar	
<p>Sketch of damage</p>

<p>Labels in sketch: Rail for hatch cover, Compression bar, Starting point (See "Detail"), Fractures, Hatch side coaming, Compression bar (or rail for hatch cover), Welded joint, Fracture, Hatch coaming top plate.</p> <p>Detail</p>		<p>Sketch of repair</p>

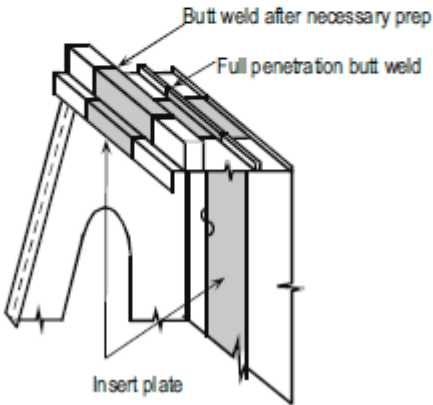
<p>Labels in sketch: Butt weld after necessary prep, Full penetration butt weld, Insert plate.</p>	
<p>Notes on possible cause of damage</p> <ol style="list-style-type: none"> 1. Heavy weather 2. Insufficient preparation of weld of compression bar and/or rail (Although the compression bar and rail are not longitudinal strength members, they are subject to the same longitudinal stress as longitudinal members) 3. Fracture may initiate from insufficient penetration of weld of rail for hatch cover. 		<p>Notes on repairs</p> <ol style="list-style-type: none"> 1. Loading condition of the ship and proper welding procedure should be carefully considered. 2. Fractured structure is to be cropped and renewed if considered necessary (a small fracture may be veed-out and rewelded.) 3. Full penetration welding should be applied to the butt weld of compression bar and rail.

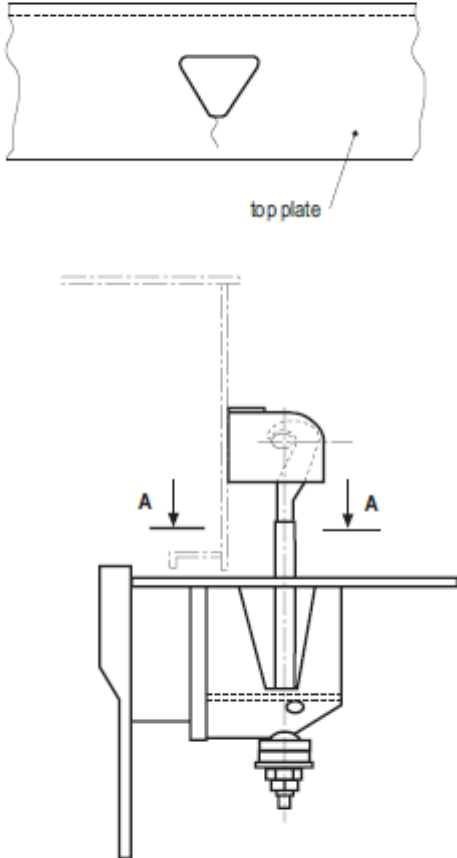
CONTAINER SHIPS		Guidelines for Surveys, Assessment and Repair of Hull Structures	
PART 1	Cargo hold region		EXAMPLE No.
AREA 1	Upper deck structure including passageways		10
Detail of damage		Fracture in hatch coaming top plate in way of quick-acting cleat	
<p>Sketch of damage</p> <p>Section A-A</p>

<p>Notes on possible cause of damage</p> <ol style="list-style-type: none"> 1. Stress concentration at hole 2. Inadequate design 3. Poor workmanship 		<p>Notes on repairs</p> <ol style="list-style-type: none"> 1. Damaged area to be cropped and renewed. 2. Elliptical hole to be provided for the quick acting cleat

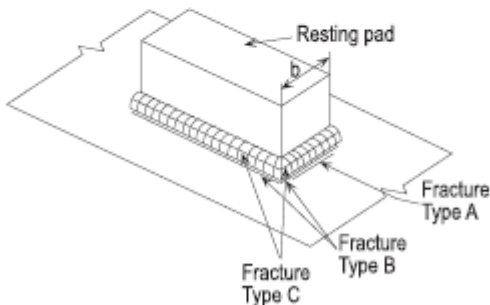
CONTAINER SHIPS		Guidelines for Surveys, Assessment and Repair of Hull Structures	
PART 1	Cargo hold region		EXAMPLE No.
AREA 1	Upper deck structure including passageways		11
Detail of damage		Fractures in hatch coaming top plate around resting pad	
<p>Sketch of damage</p>

<p>Fracture Type A: Starting in way of the undercut or HAZ of the transverse fillet weld and propagating in the top plating.</p> <p>Fracture Type B: Starting in way of the undercut or HAZ of the longitudinal fillet weld and propagating in the top plating.</p> <p>Fracture Type C: Starting and propagating in fillet weld</p>		<p>Sketch of repair</p> <p>Repair for "Fracture Type A" Note: Cut, if the pad has enough area</p>

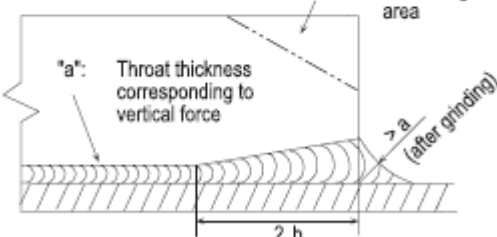
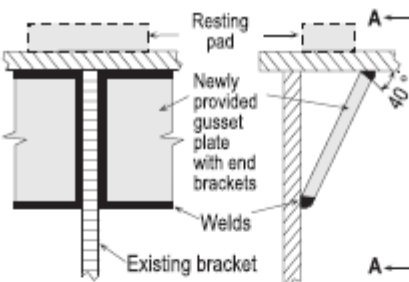
<p>Repair for "Fracture Type B"</p>

<p>View A-A</p>	
<p>Notes on possible cause of damage</p> <ol style="list-style-type: none"> Fracture Type A: Inappropriate transition from the hatch coaming top plating to the resting pad in respect to longitudinal stresses. Fracture Type B: Insufficient support of the resting pad below the top plating. Fracture Type C: Insufficient throat thickness of the fillet weld in relation to the vertical forces. 		<p>Notes on repairs</p> <ol style="list-style-type: none"> Fracture Type A: Modification of the transverse fillet weld according to the sketch; in some cases smoothing of the transition by grinding is acceptable. Fracture Type B: Strengthening of the structures below the top plating according to the sketch. Fracture Type C: Increasing the throat thickness corresponding to the acting vertical forces.

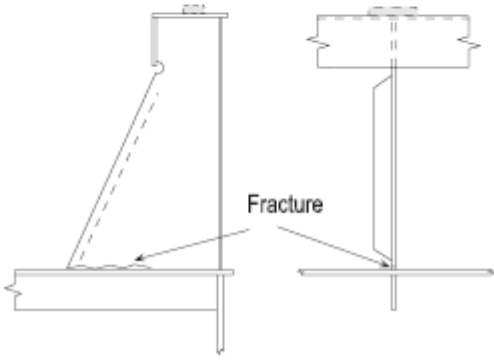
CONTAINER SHIPS		Guidelines for Surveys, Assessment and Repair of Hull Structures	
PART 1	Cargo hold region	EXAMPLE No.	
AREA 1	Upper deck structure including passageways	12	
Detail of damage		Fractures in web of transverse hatch coaming stay	
<p>Sketch of damage</p>

<p>Notes on possible cause of damage</p> <ol style="list-style-type: none"> 1. Insufficient consideration of the horizontal friction forces in way of the resting pads for hatch cover. 		<p>Notes on repairs</p> <ol style="list-style-type: none"> 1. Modification of the design of the hatch coaming stay. 2. Full penetration welding between gusset plates and deck plating. 3. Strengthening and continuation of the structure below the deck. 4. Use pads with smaller coefficient of friction.

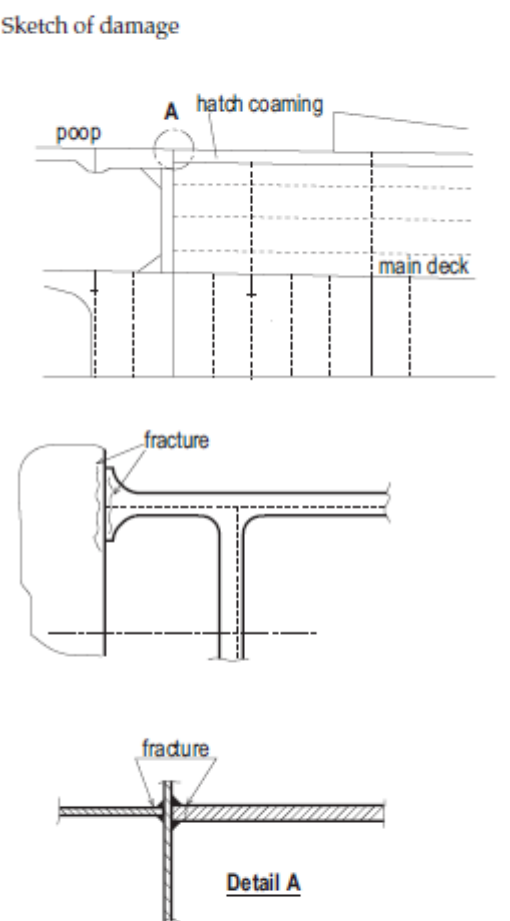
CONTAINER SHIPS		Guidelines for Surveys, Assessment and Repair of Hull Structures	
PART 1	Cargo hold region	EXAMPLE No.	
AREA 1	Upper deck structure including passageways	13	
Detail of damage		Fractures at the connection of the web of the transverse hatch coaming stay	
<p>Sketch of damage</p>

<p>Notes on possible cause of damage</p> <ol style="list-style-type: none"> 1. Insufficient transfer of forces from hatch coaming top plate into poop deck plating by cruciform connection. 		<p>Notes on repairs</p> <ol style="list-style-type: none"> 1. Cutting of the connection between longitudinal hatch coaming and poop in the case that the strength requirements are satisfactory (see Repair A). 2. Continuation of hatch coaming top plate by inserting thick plate into the thin poop deck plating (chamfer 1:5) see Repair B.

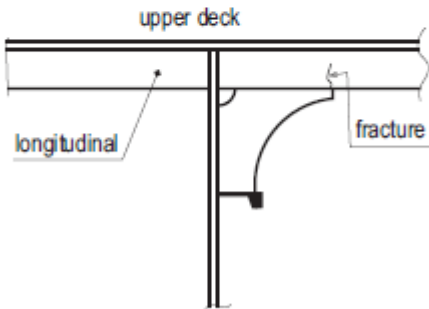
CONTAINER SHIPS		Guidelines for Surveys, Assessment and Repair of Hull Structures	
PART 1	Cargo hold region		EXAMPLE No.
AREA 1	Upper deck structure including passageways		14
Detail of damage		Fracture in deck longitudinal	
<p>Sketch of damage</p>

<p>$c \leq 2 t_2 \text{ max. } 25 \text{ mm}$ $r \geq 0,5 h$</p>	
<p>Notes on possible cause of damage</p> <ol style="list-style-type: none"> 1. Stress concentration at bracket toe 2. Bracket toe too high 3. Poor workmanship 		<p>Notes on repairs</p> <ol style="list-style-type: none"> 1. Damaged area to be cropped and renewed. 2. New bracket with soft toe to be added.

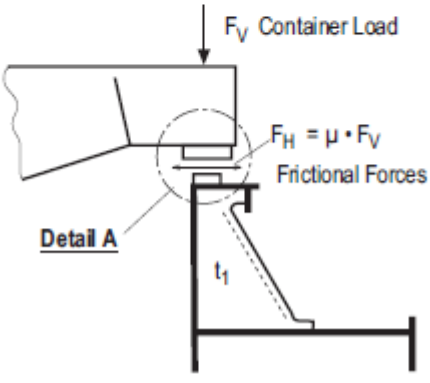
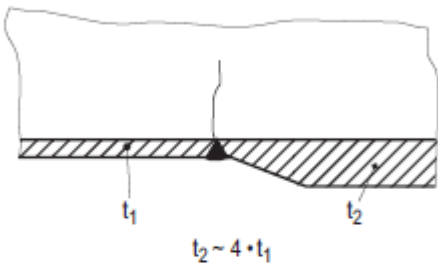
CONTAINER SHIPS		Guidelines for Surveys, Assessment and Repair of Hull Structures	
PART 1	Cargo hold region	EXAMPLE No.	
AREA 1	Upper deck structure including passageways	15	
Detail of damage		Fractures in a longitudinal hatch cover girder	
<p>Sketch of damage</p>

<p>Detail A</p>

<p>Notes on possible cause of damage</p> <ol style="list-style-type: none"> 1. Stress concentration 2. Incorrect tapering leads to additional flange bending 3. Poor workmanship 		<p>Notes on repairs</p> <ol style="list-style-type: none"> 1. Damaged area to be cropped off and renewed 2. Flange with intermediate thickness to be fitted.

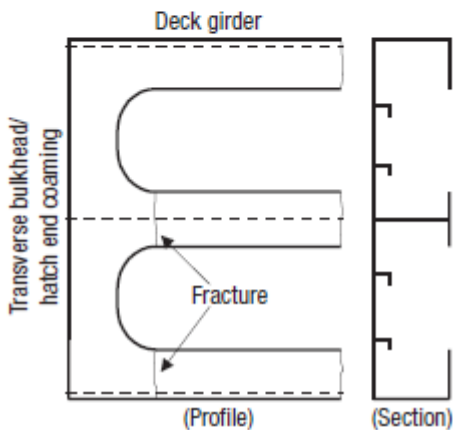
CONTAINER SHIPS		Guidelines for Surveys, Assessment and Repair of Hull Structures	
PART 1	Cargo hold region		EXAMPLE No.
AREA 1	Upper deck structure including passageways		16
Detail of damage		Fractures in deck girder	
<p>Sketch of damage</p>

<p>Deck girder</p> <p>Transverse bulkhead/hatch end coaming</p> <p>Fracture</p> <p>(Profile) (Section)</p>		<p>Sketch of repair</p>

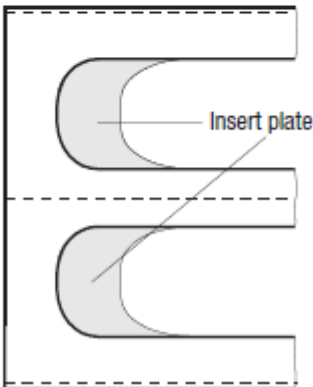
<p>Insert plate</p>	
<p>Notes on possible cause of damage</p> <ol style="list-style-type: none"> 1. Insufficient rigidity at the end of deck girder against bending and torsion 		<p>Notes on repairs</p> <ol style="list-style-type: none"> 1. Fractured parts are to be cropped and partially renewed. 2. Insert plate at the end of deck girder as shown in sketch of repair.
